Norwegian vessel cuts engine oil consumption by more than 50%

Just 18 months after delivery from the shipyard where she was built, *M/V Krossfjord*, a Norwegian fishing vessel that operates in the North Atlantic, began experiencing radically increased oil consumption due to lacquer formations in the engine's cylinder liners.

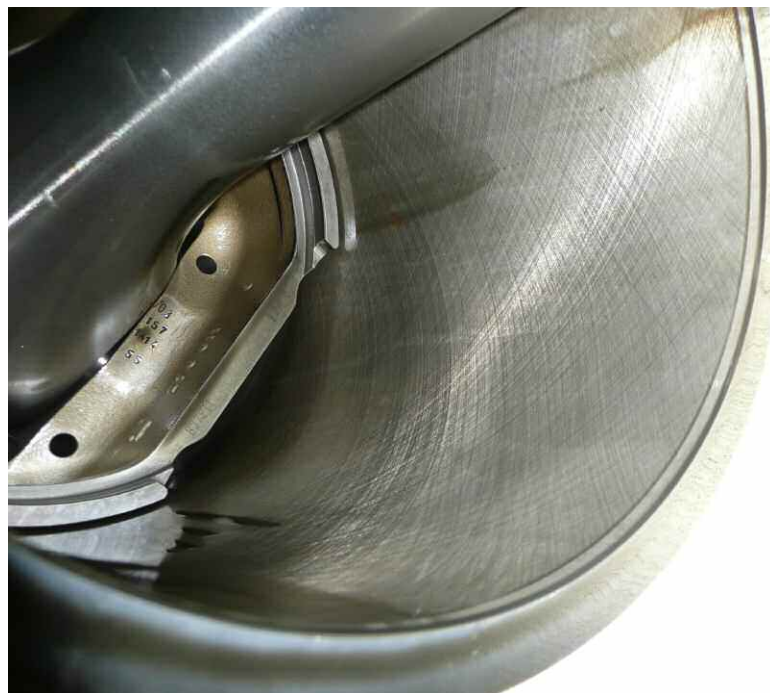
The cylinder inspection showed that all honing marks were clearly visible. No bore polishing or lacquering was noted.

inspection. This included a borescope inspection of all nine cylinder liners, inspection of the crankcase and camshaft housing, and evaluation of the filtration process.

The cylinder inspection showed that all honing marks were clearly visible. No bore polishing or lacquering was noted. There was slight discoloration in the number 3 cylinder liner covering a fourth of the circumference towards the front end of the engine, but honing marks were still clearly visible. No discoloration was noted in the other liners.

The combustion chamber was also inspected with the borescope. All surfaces, including the valve heads, were relatively clean, with only very light deposits.
