## MobilGard<sup>™</sup> cylinder condition monitoring

## An advanced condition monitoring programme to optimise engine performance

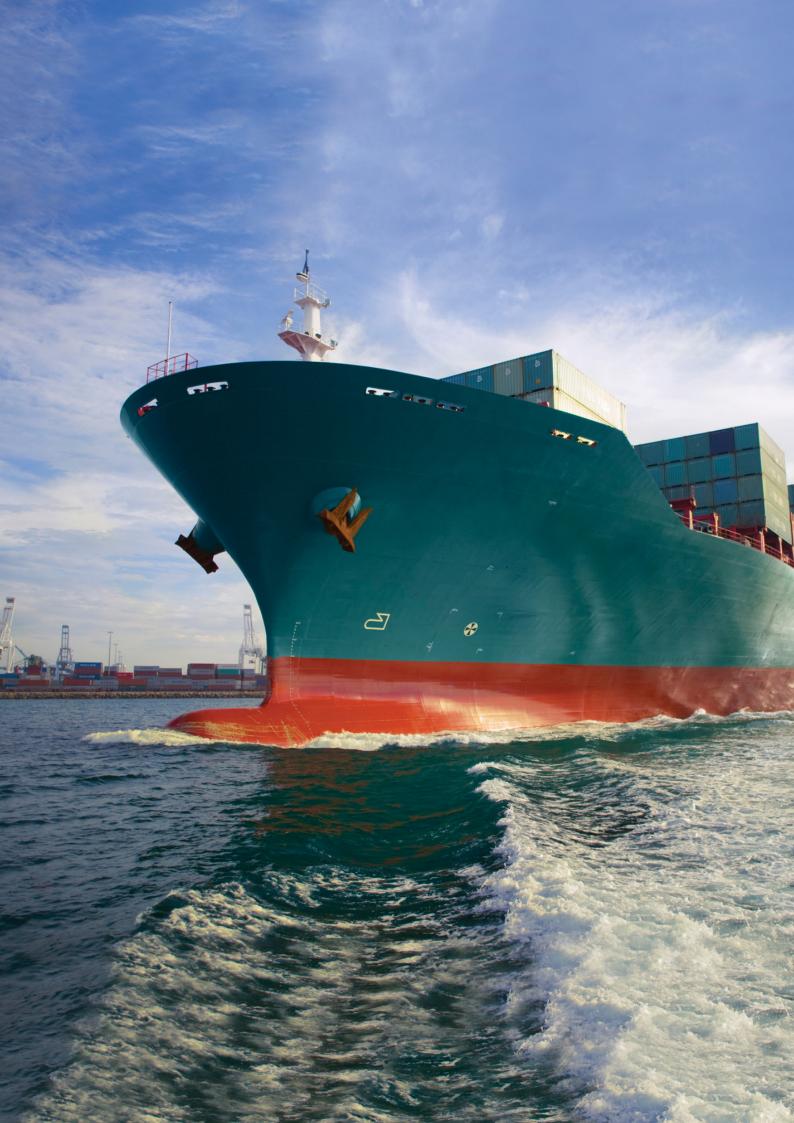
The MobilGard<sup>™</sup> Monitor tests scrape down oil for indications of abrasive wear on engine liners. The MobilGard Monitor contains a highly sensitive measuring head that detects ferrous iron particles in oil. Accurate calibration is ensured using the set of reference bottles that are supplied with the unit.

The MobilGard Corrosion Check Kit includes a non-toxic reactant, which enables users to quickly and easily check for the presence of iron salts – the result of corrosive wear on an engine's cylinder liners. This test enables users to uncover an engine's liner corrosive wear rate and act immediately to rectify any cold corrosion issues.

The Digicell Easyship kit provides a quick and easy on-board test for the level of residual BN in oil scrape down samples. The kit's output enables operators to see if a vessel's engine liners are being protected from the acidic products caused during combustion and the associated corrosive wear.

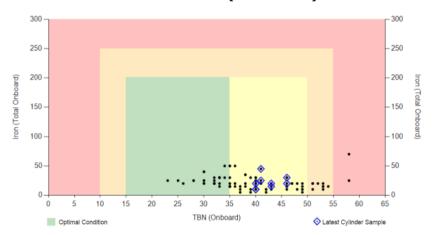
#### Iron vs TBN (Onboard)

#### Graph Key

#### Green:

Results are healthy and it is unlikely significant wear will occur if conditions remain unchanged.

#### Orange:

Results are reasonably healthy but if left unchecked may lead to elevated wear and engine damage.

#### Red:

Results are outside OEMs recommended limits and action is required to prevent engine damage.

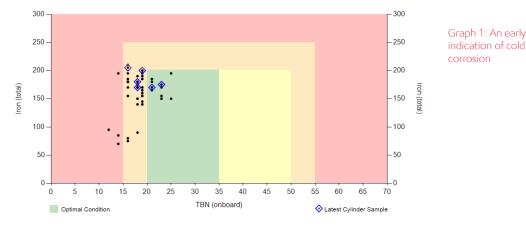
Iron vs TBN (onboard)

The first graph alerted ExxonMobil engineers to the early indication of cold corrosion for this six cylinder two-stroke marine engine, which, if left unchecked, could have resulted in significant damage to its cylinder liners. It was recommended that the vessel should move from a 70BN cylinder oil to Mobilgard<sup>™</sup> 5100, a high performance 100BN alternative.

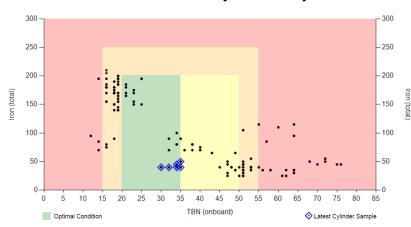
Graph 2: Improved results following a switch to a higher BN oil

A second sample [graph 2] was taken by the crew in partnership with ExxonMobil's CCM team following the switch and 3,000 operating hours. It shows that the risk of cold corrosion has been mitigated.

Following the switch to Mobilgard 5100 a sweep test could have been performed to realise this benefit in a shorter period of time.

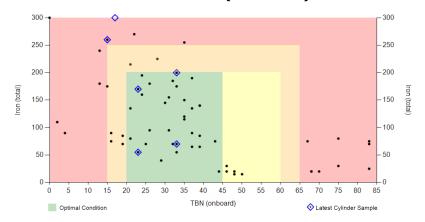
Graph 3: Damaging concentration of cat fines

The test results (graph 3) warned ExxonMobil's engineering support team that it looked likely that a damaging concentration of cat fines was present in the fuel, which was leading to the high iron readings in the scrape down sample. With the expertise of ExxonMobil engineering teams – the vessel's fuel purifier throughput was reduced, which improved the fuel purifier performance, and an increased sampling frequency helped to monitor improvement. This issue could have gone unnoticed and resulted in significant abrasive wear if the cylinder condition monitoring programme had not been put in place. This was all achieved in close collaboration with ExxonMobil.

Disrupted fuel tank sediment and off-spec fuel can result in an increase of cat fines (aluminium and silicon) in the fuel system. If left untreated this can result in costly engine wear.

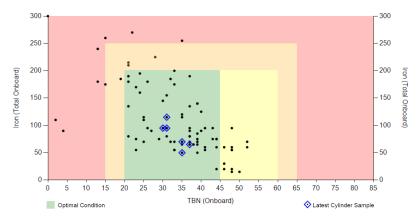
Graph 4: Reduced cat fines due to increased purifier operation

A second sample taken after 2,000 hours of increased purifier operation and close monitoring of on board test data by the ExxonMobil CCM team showed the issue had been resolved [graph 4].
